DEPARTMENT OF TRANSPORTATION

Contract #: 04-0120F4Cty: SF/ALA Rte: 80 PM: 13.2/13.9File #: 69.28**WELDING INSPECTION REPORT****Resident Engineer:**Siegenthaler, Peter**Address:** 333 Burma Road**City:** Oakland, CA 94607**Report No:** WIR-016899**Date Inspected:** 13-Sep-2010**Project Name:** SAS Superstructure**OSM Arrival Time:** 700**Prime Contractor:** American Bridge/Fluor Enterprises, a JV**OSM Departure Time:** 1900**Contractor:** Zhenhua Port Machinery Company, Ltd (ZPMC), Changxing Island **Location:** Shanghai, China**CWI Name:** Liu Hua Jie**CWI Present:** Yes No**Inspected CWI report:** Yes No N/A**Rod Oven in Use:** Yes No N/A**Electrode to specification:** Yes No N/A**Weld Procedures Followed:** Yes No N/A**Qualified Welders:** Yes No N/A**Verified Joint Fit-up:** Yes No N/A**Approved Drawings:** Yes No N/A**Approved WPS:** Yes No N/A**Delayed / Cancelled:** Yes No N/A**Bridge No:** 34-0006**Component:** Orthotropic Box Girder(OBG)**Summary of Items Observed:**

OBG # TRIAL ASSEMBLY YARD**Segment # 10AW ~ 10BW**

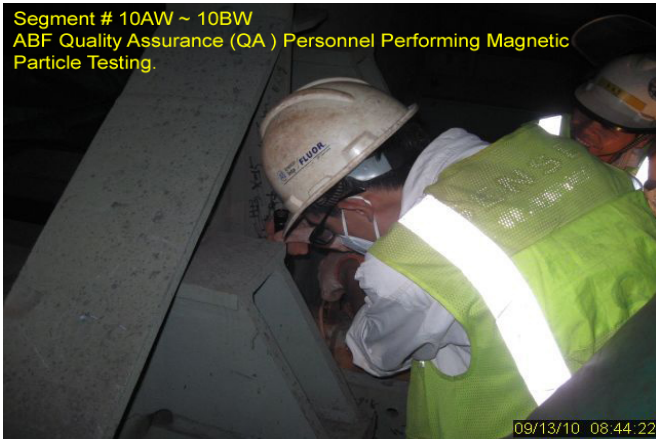
During random visual inspection this Caltrans Quality Assurance (QA) inspector observed that American Bridge Fluor (ABF) Quality Assurance (QA) personnel had performed Magnetic Particle Testing (MT) on Bottom Plate to Side Plate Transverse CJP Weld. in OBG segment 10AW ~ 10BW. See the attached Photo.

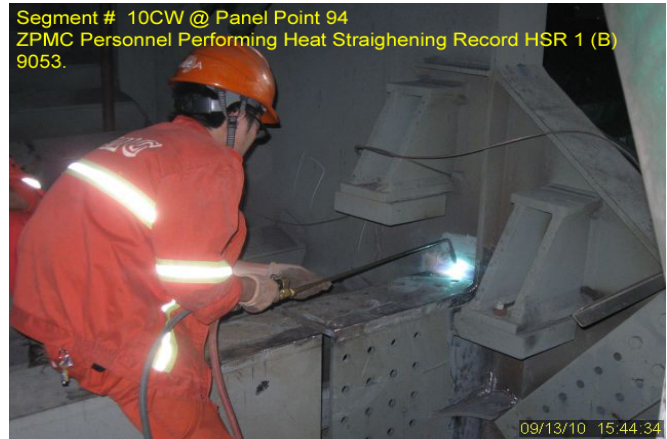
During random visual inspection this Caltrans Quality Assurance (QA) inspector observed that ZPMC personnel had performed heat straightening on various locations on longitudinal Diaphragm in OBG segment 10CW at panel point 94. ZPMC QC is identified as Mr. Zhong Peng the variables recorded by QC appeared to comply with the Heat Straightening Report (HSR) was HSR1 (B) 9053. See the attached Photo.
